Westinghouse Astronuclear Laboratory

WANL-TNR-224

NRX-A6 FINAL REPORT

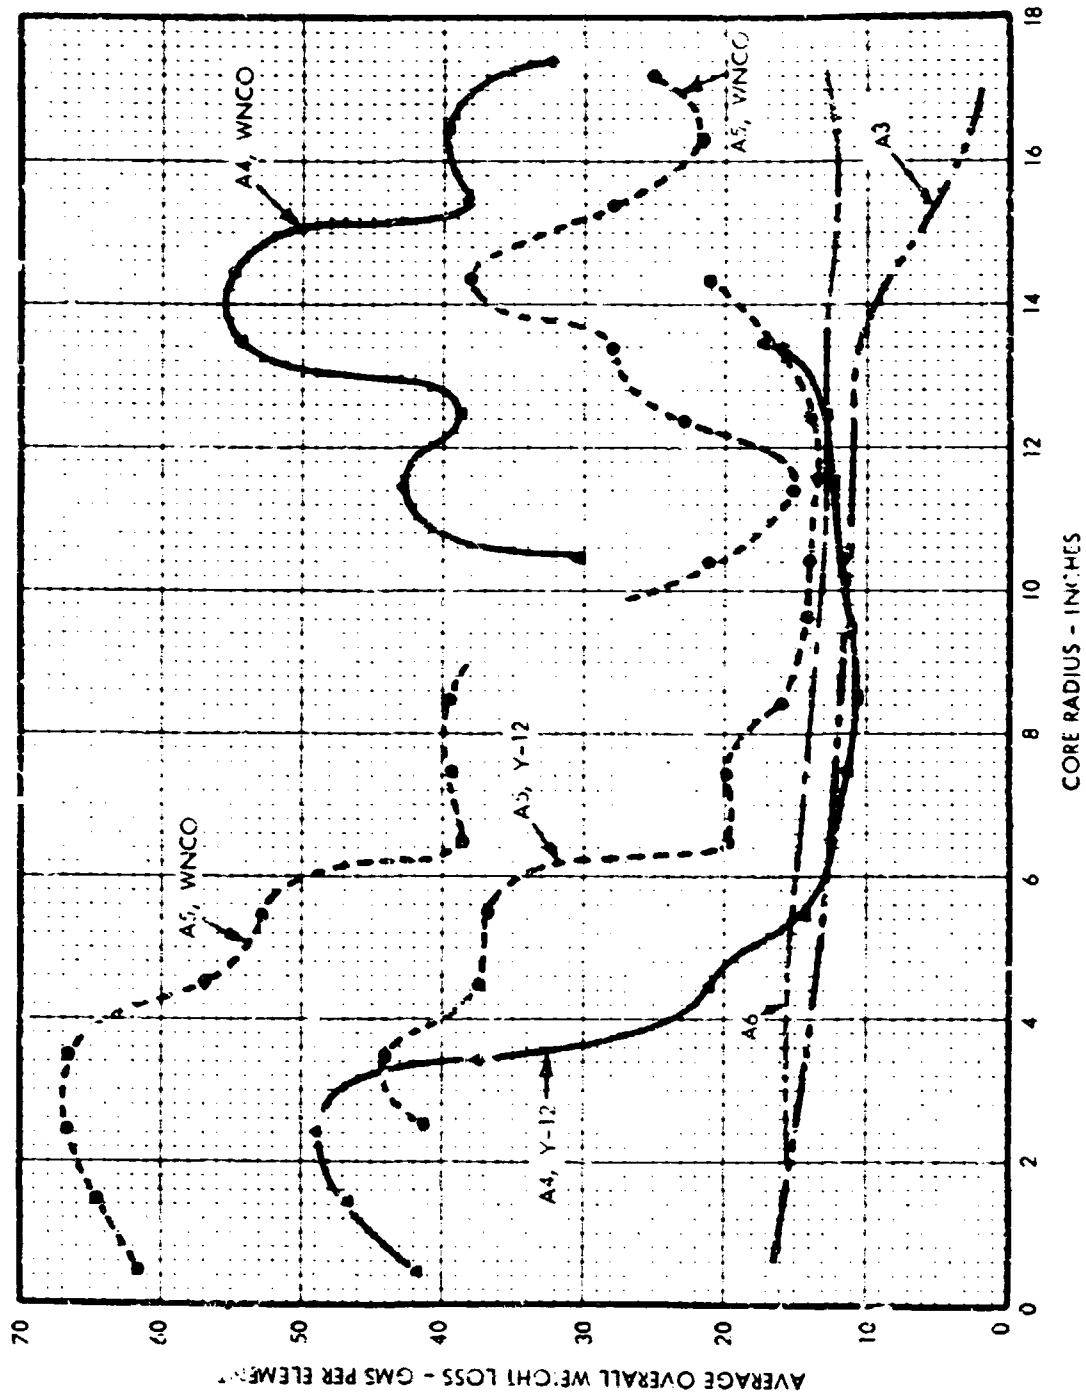
Figure 5-16. (CRD) Radial Distribution of Overall Weight Losses in the
NRX-A3, NRX/EST, NRX-A5, and NRX-A6 (U)

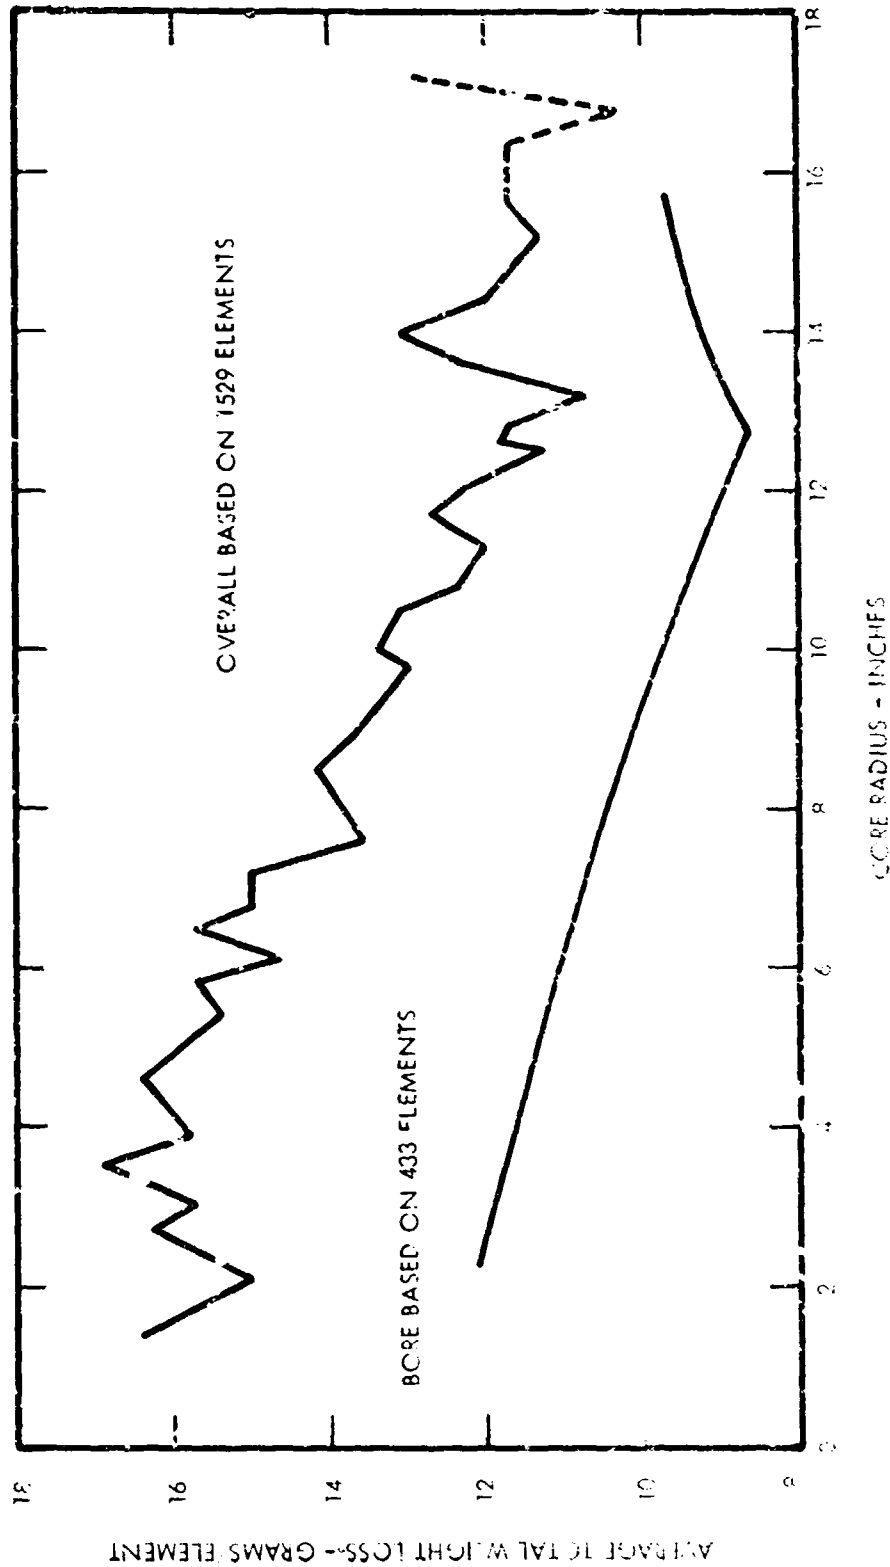
Figure 5-17. (CRB) Radial Distribution of Overall and Bore Weight Losses (U)

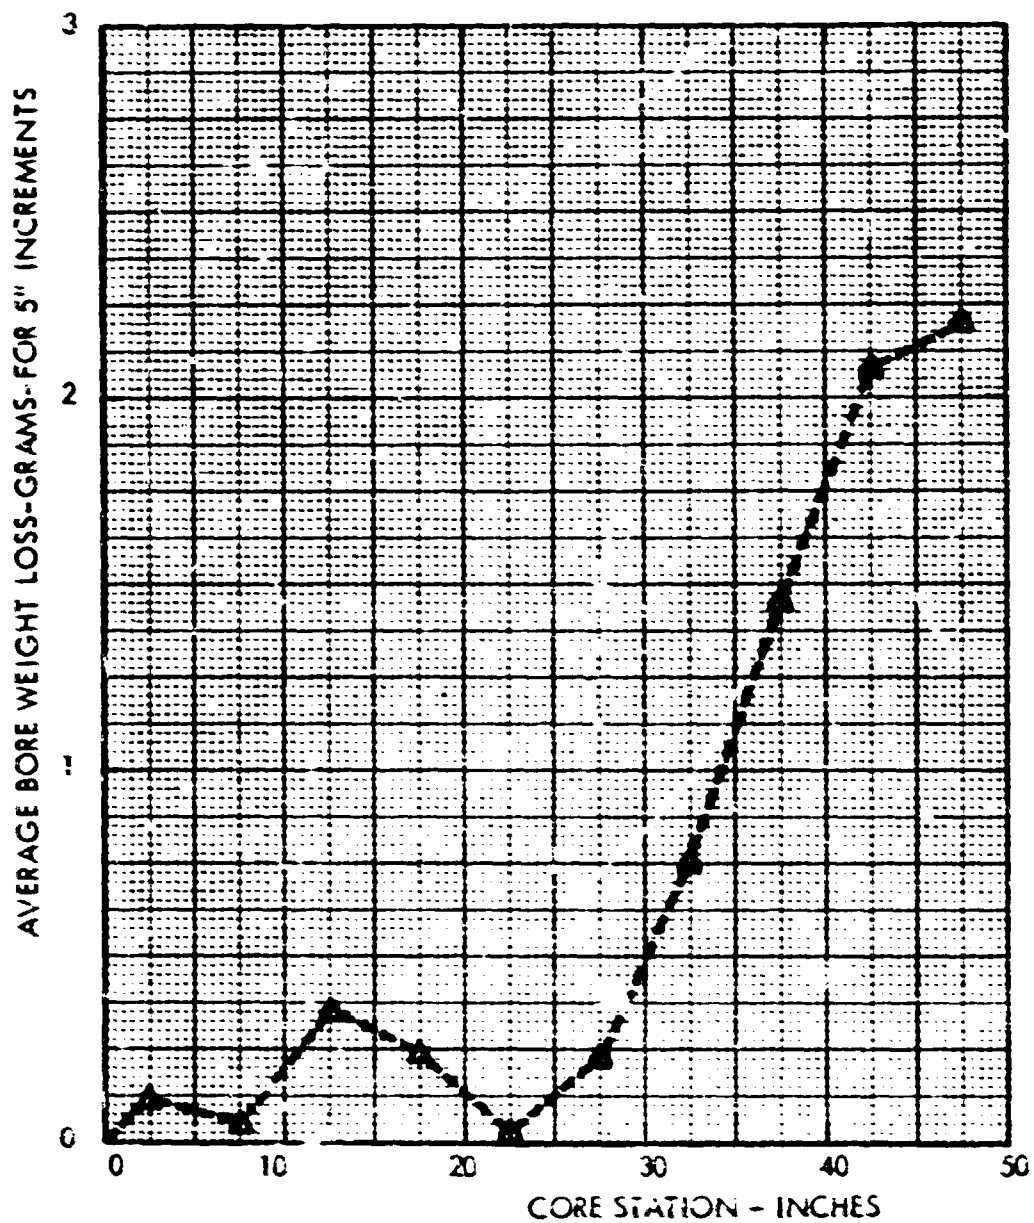
Figure 5-18. (CRD) Axial Distribution of Bore Weight Loss (G)

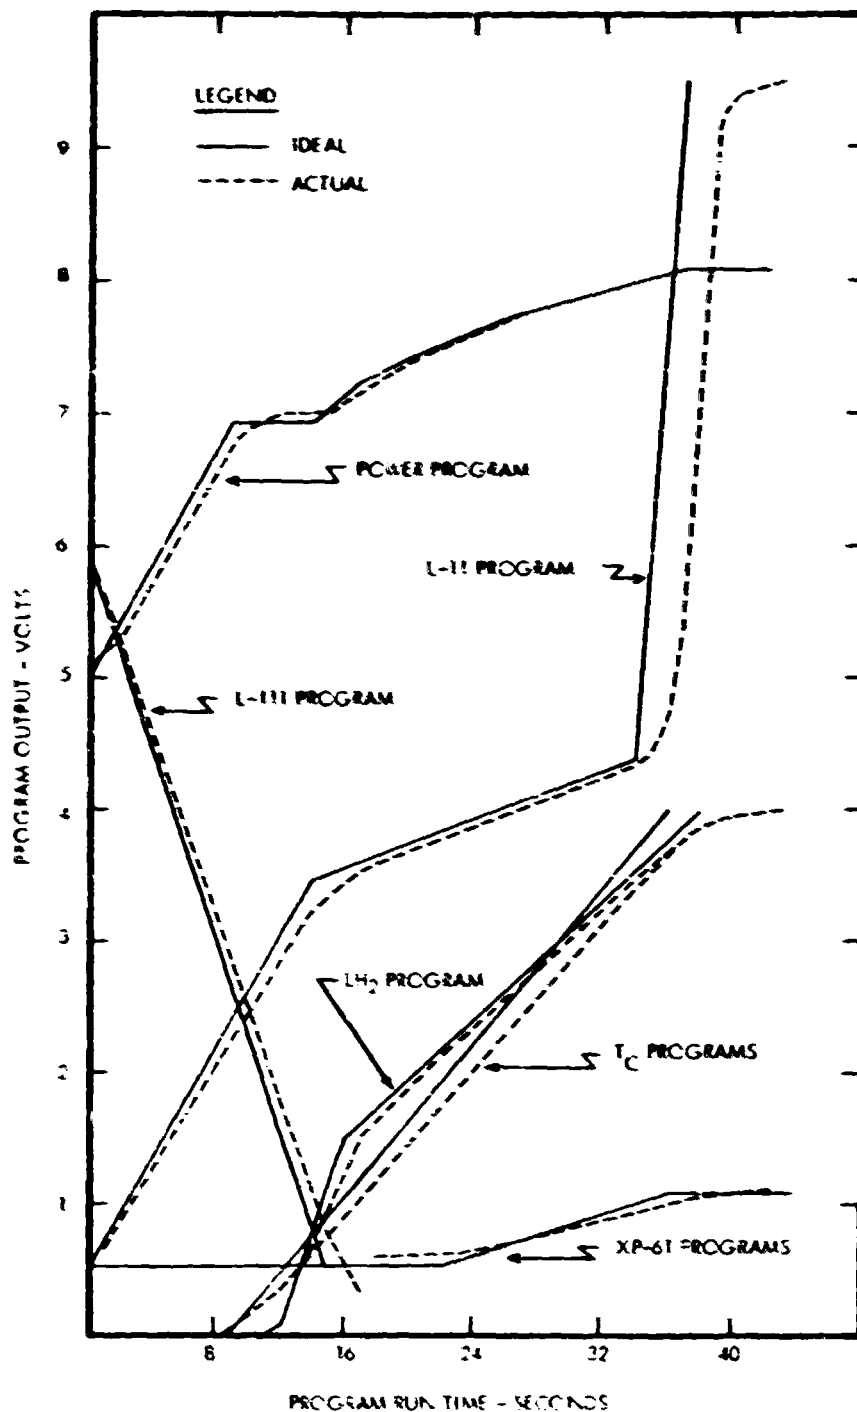
Figure 5-19. (U) Measured Versus Ideal (Synchronized) Program Outputs for EP-III A NRX-A6 Full Power Run, (Calcomp Data) (U)

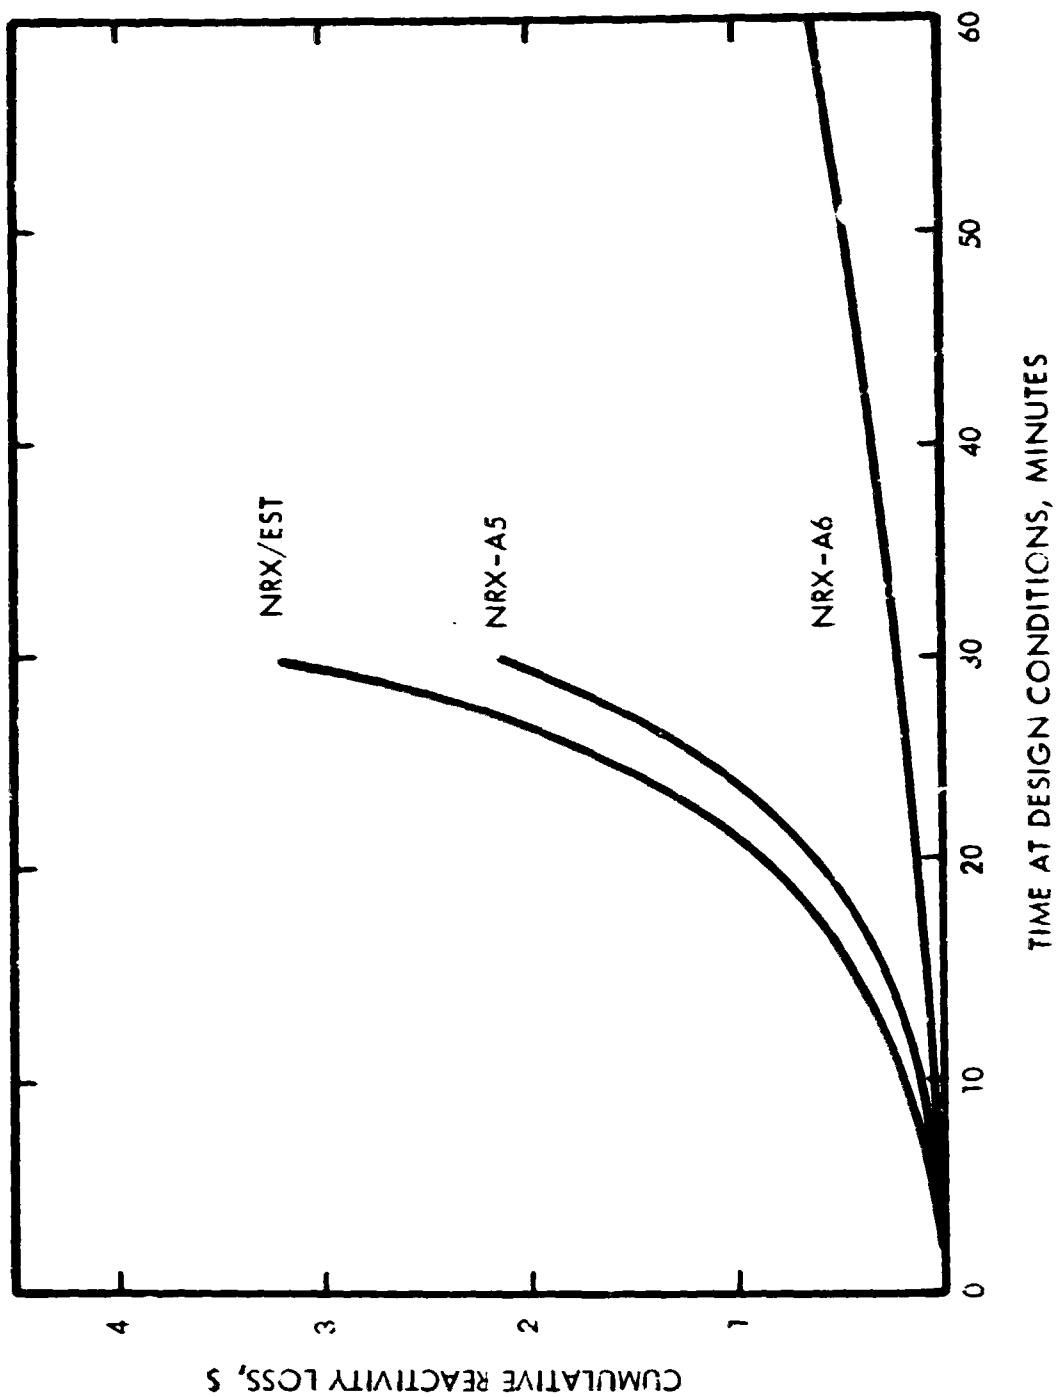
Figure 5-20. (CRD) Variation of Cumulative Reactivity Loss with Time for the NRX/EST, NRX-A5, and NRX-A6 Reactors (U)

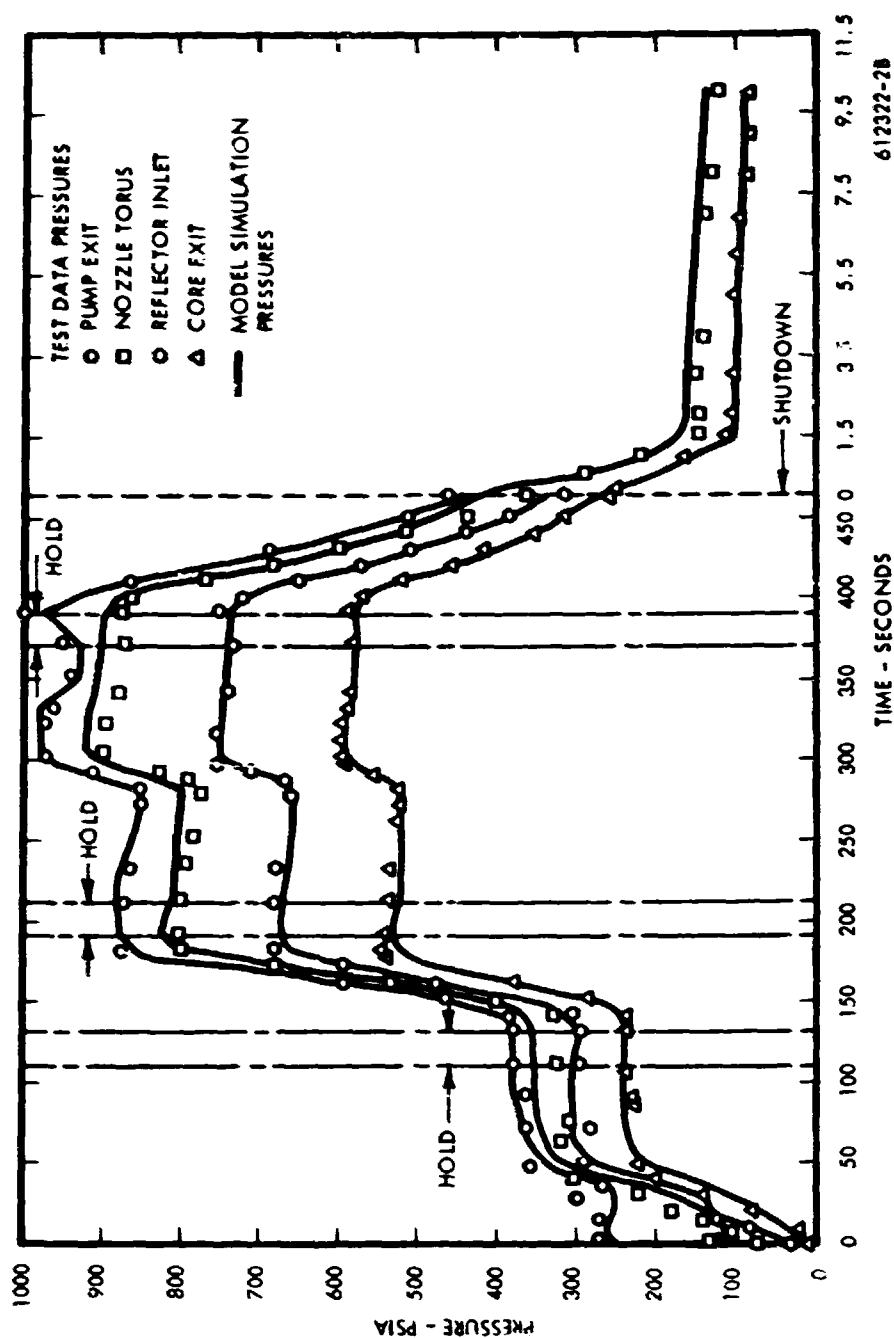
Figure 5-21. (U) Comparison of Pressures During EP-111A Full Power Run with Analog Simulation

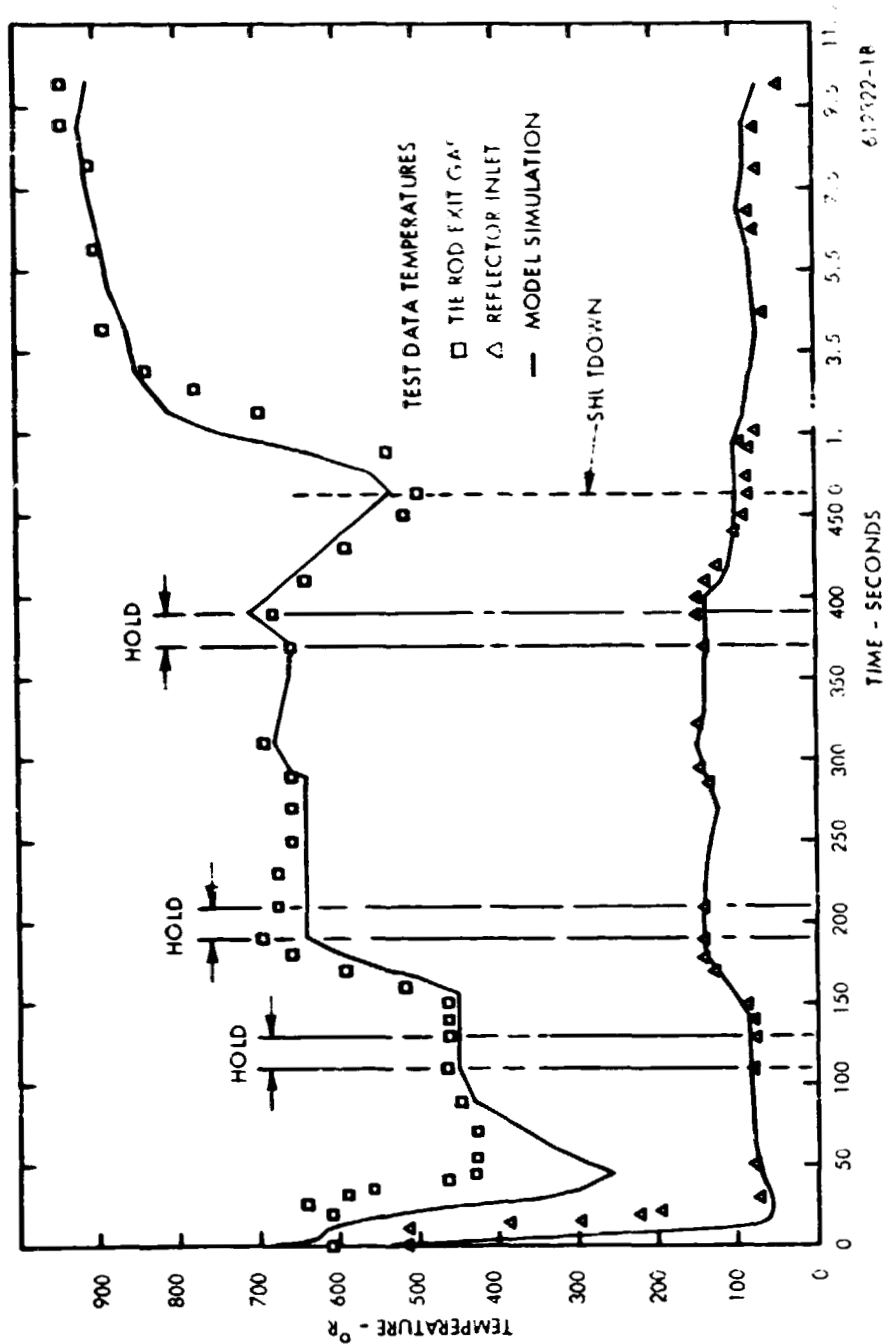
Figure 5-22. (CRD) Comparison of Temperatures During EP-III A Full Power Run with Analog Simulation (U)

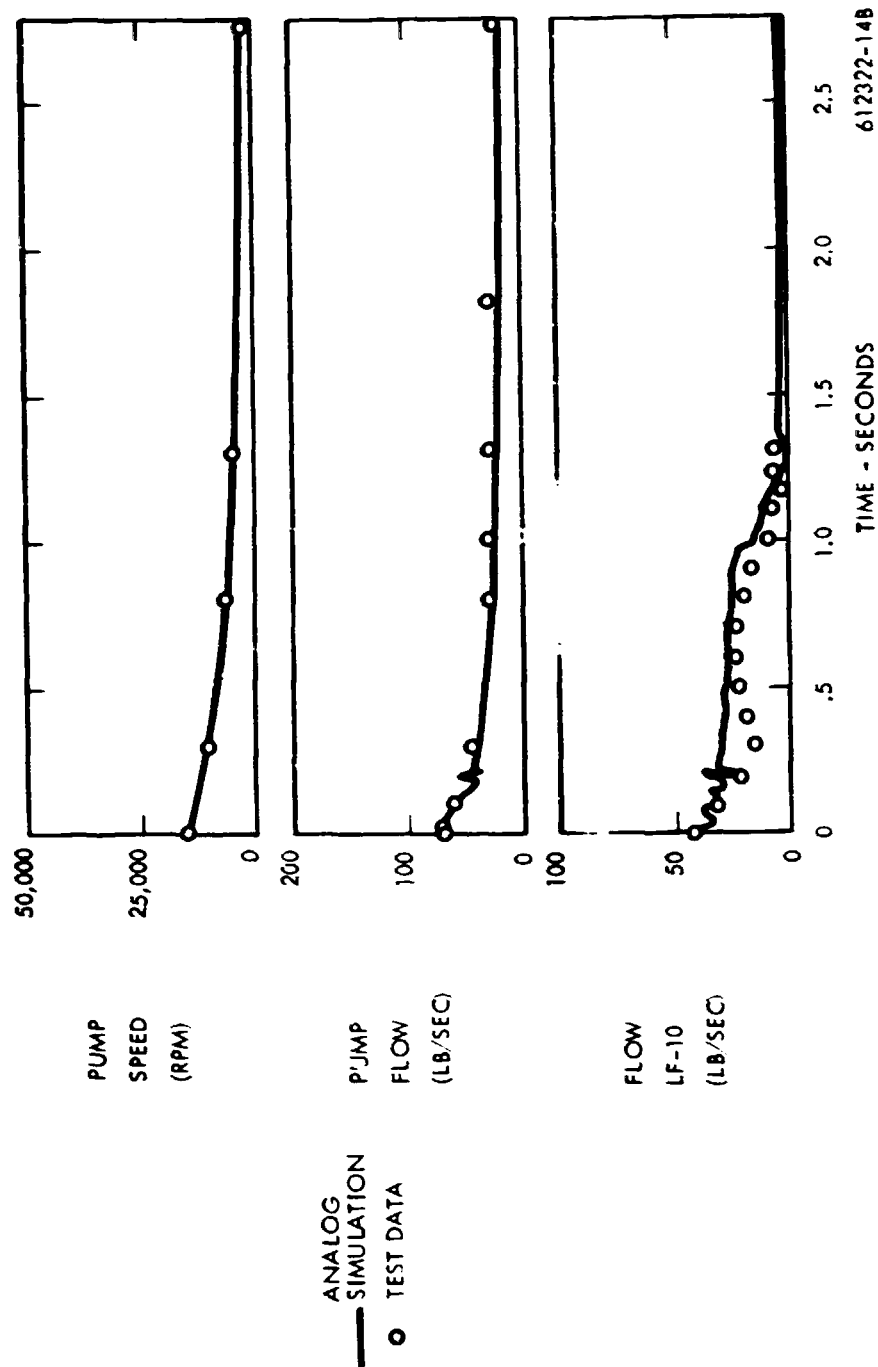
Figure 5-23. (CRD) Comparison of Shutdown Data During EP-III A Full Power Run with Analog Simulation (U)

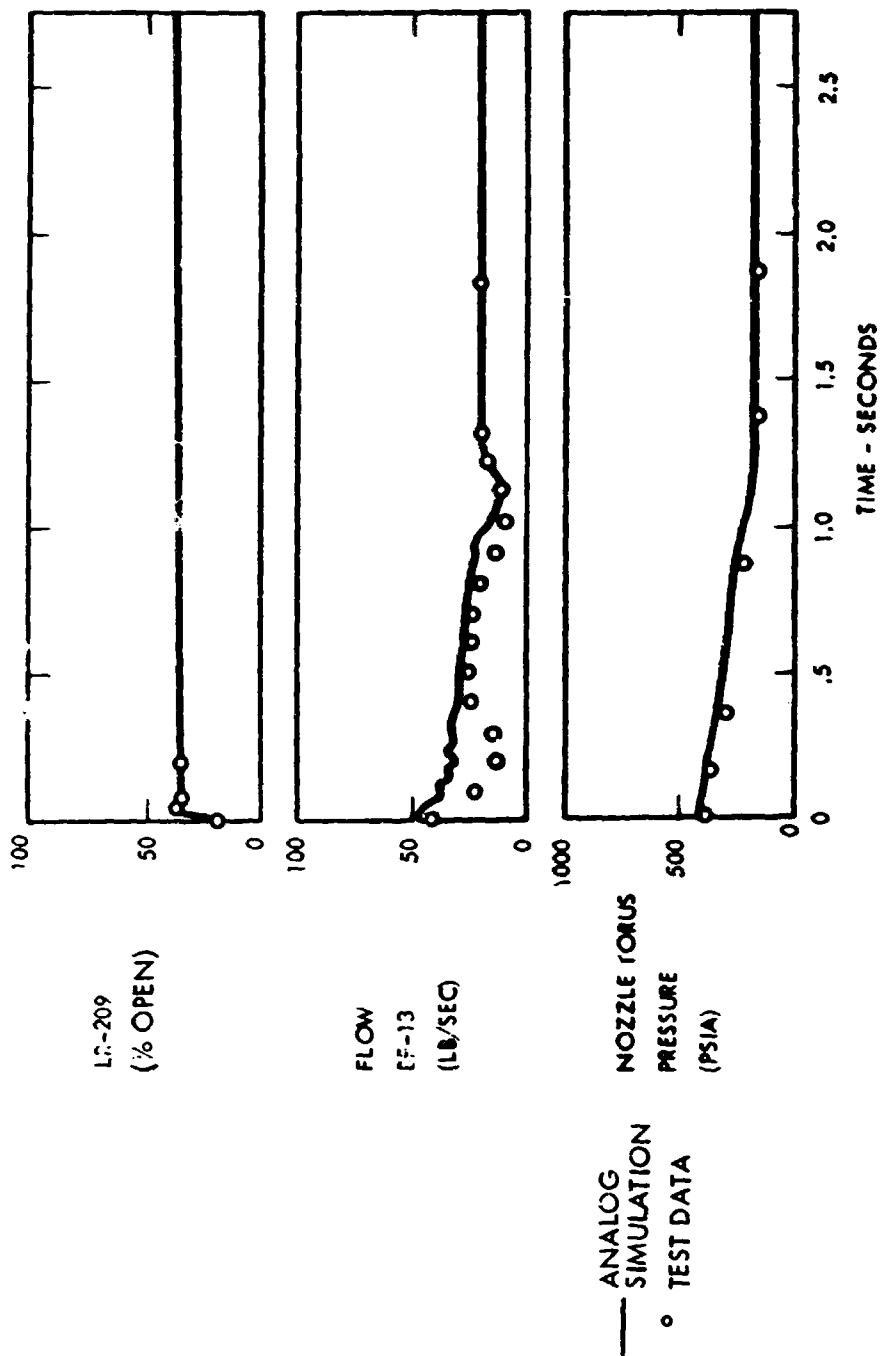
Figure 3-24. (U) Comparison of Shutdown Data During EP-111A Full Power Run with Analog Simulation (U)

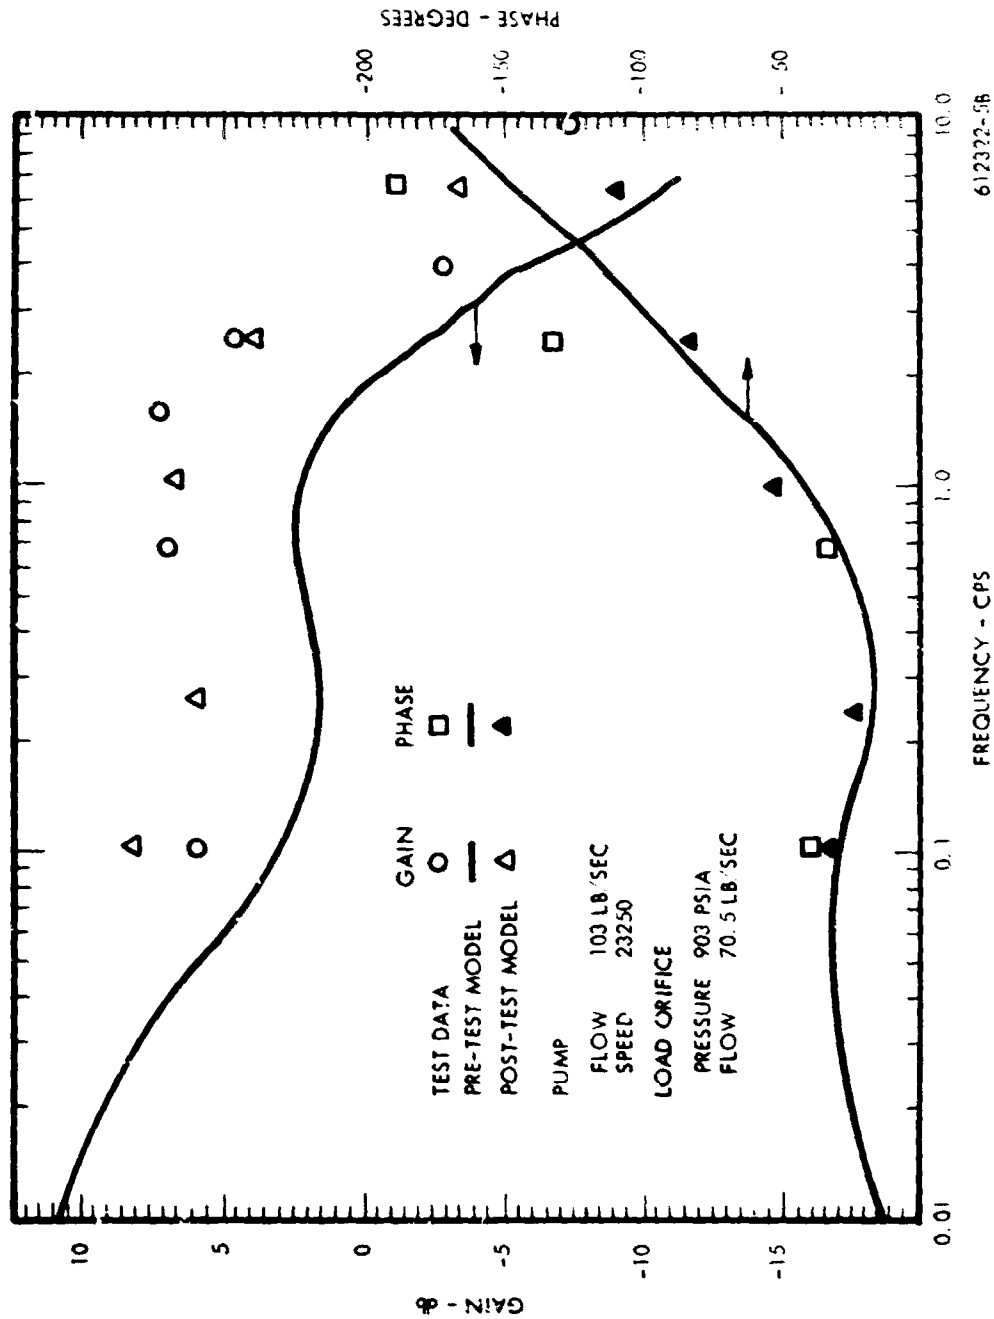
Figure 5-25. (U) NRX-A6 FEP-II Open Loop LF-10
Flow to Turbine Valve Demand Response

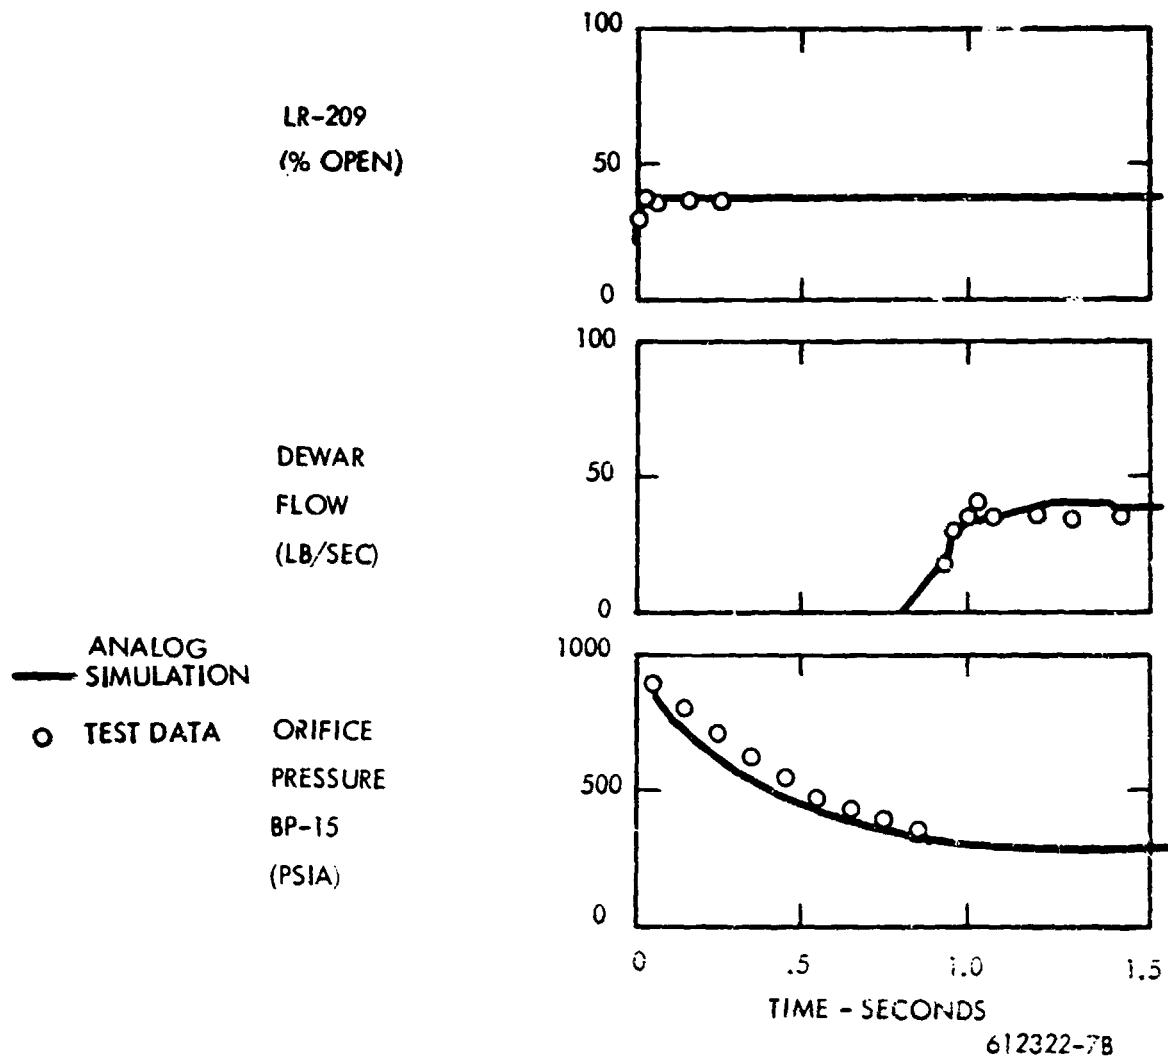
Figure 5-27. (U) Simulation of NRX-A6 FEP-III Emergency Shutdown from Design Flow

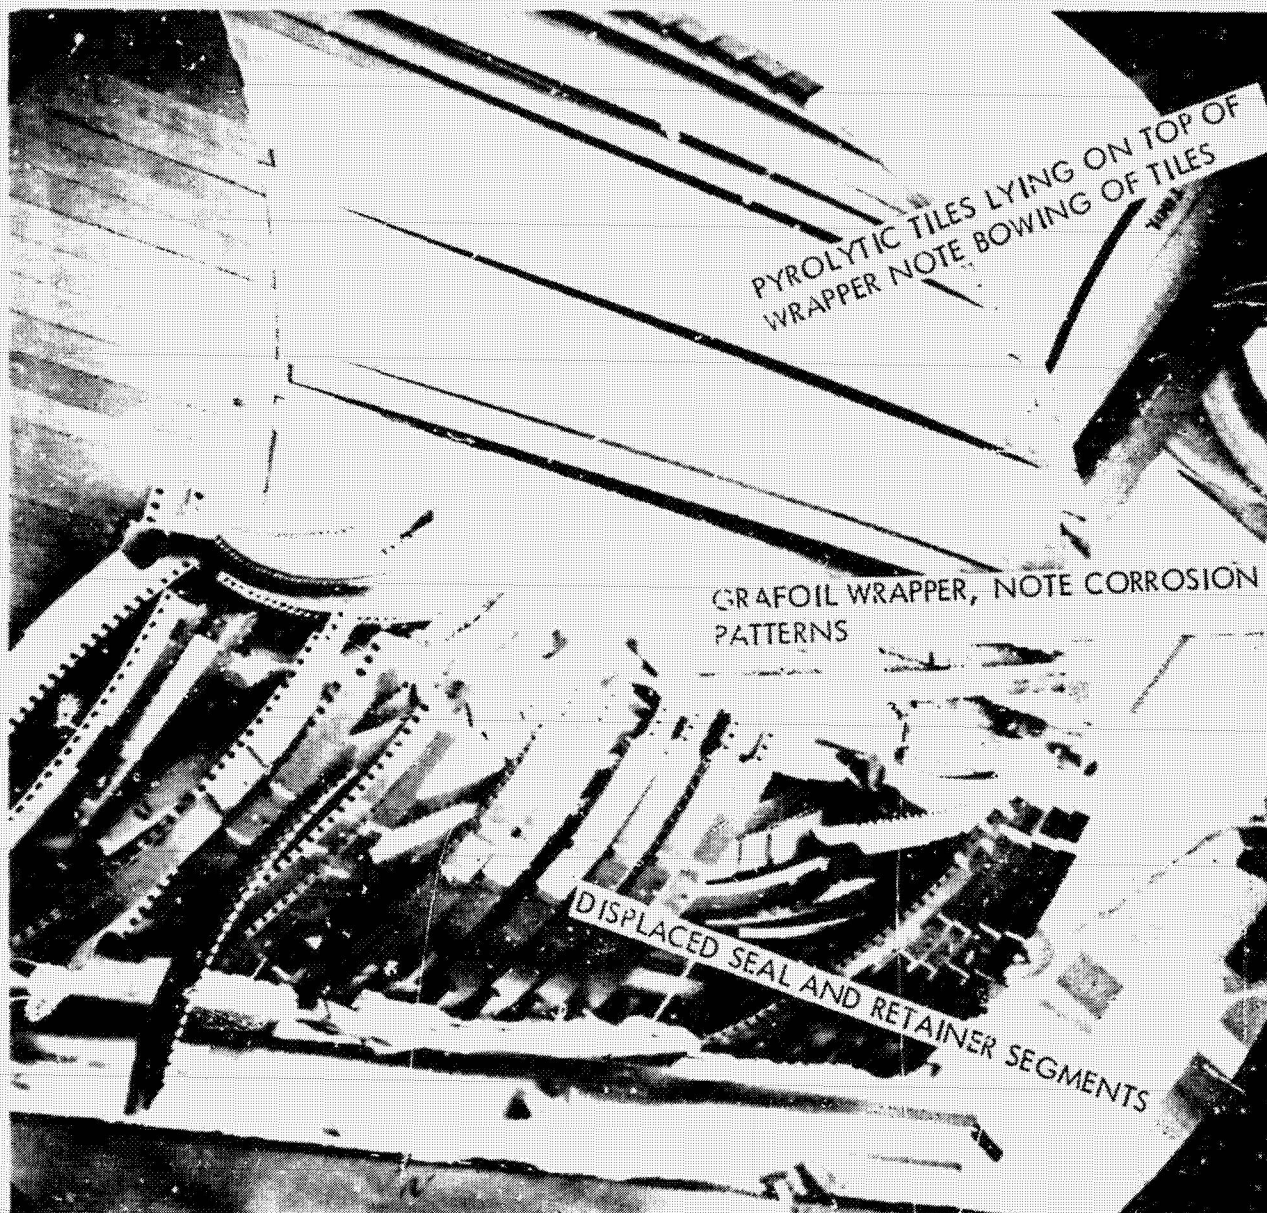
Figure 5-32. (CRD) Appearance of Insulating Tiles, Underlying
of Foil Wrapper, and Displaced Seal Segments. (CRD)

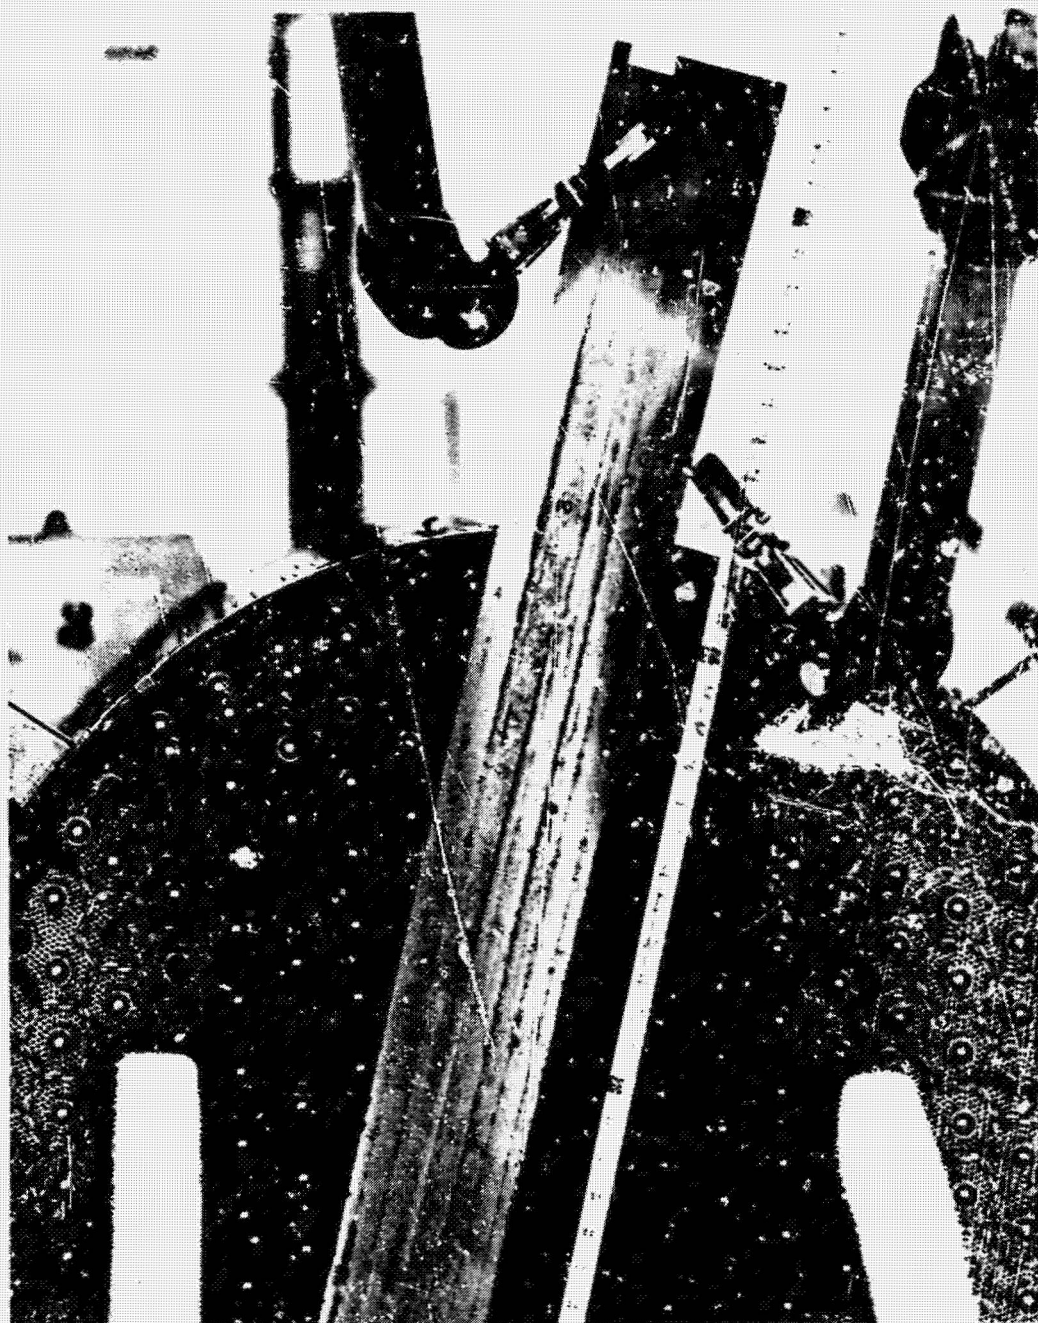
Figure 5-33. (CRD) Appearance of a Grafoil Wrapper Layer, Showing Corrosion Patterns Corresponding to Filler Strip Gaps. (CRD)

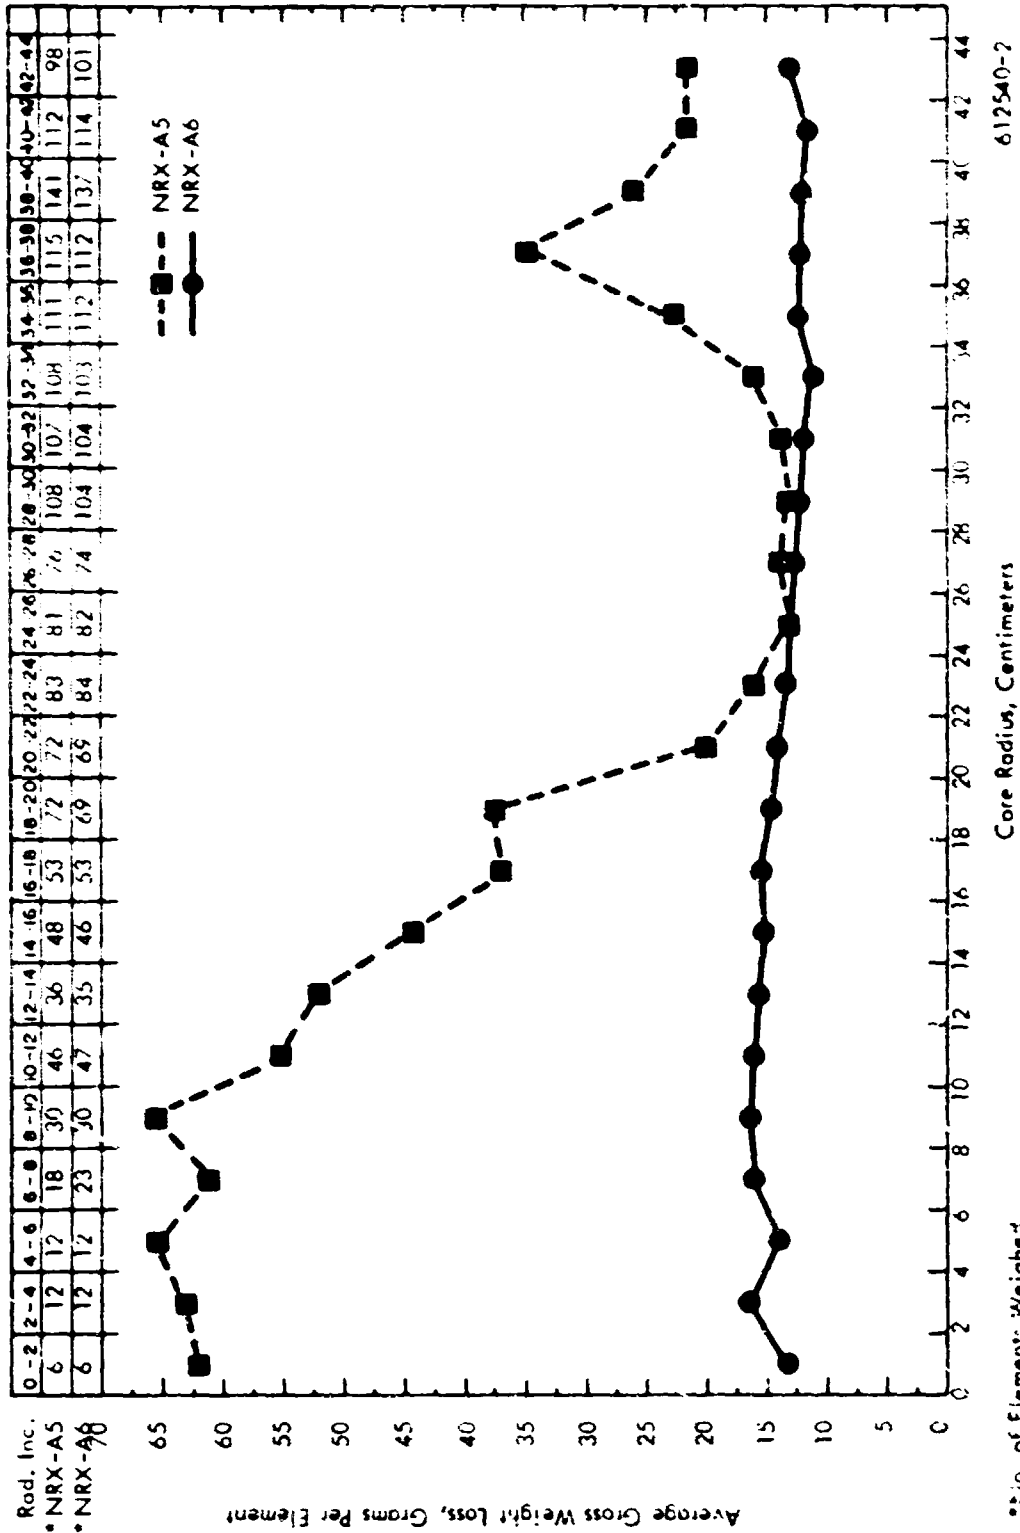
Figure 5-35. (CRU) Radial Distribution of Gross Weight Loss in NRX-A6 and NRX-A5 (U)

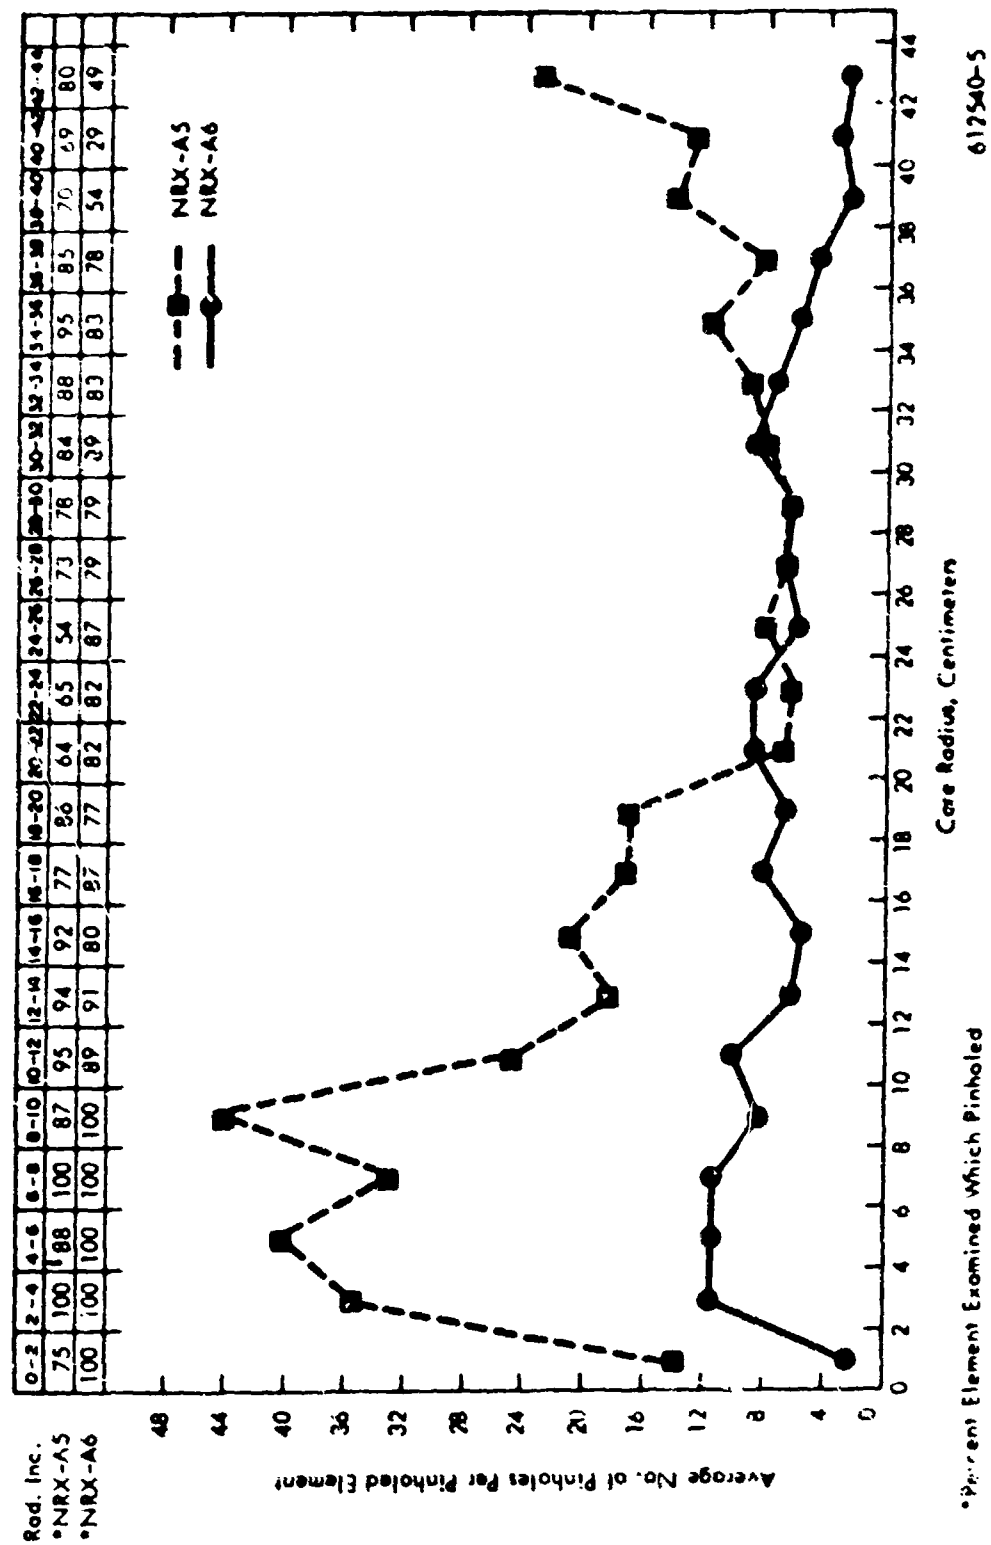
Figure 5-36. (CRU) Comparison of Radial Distribution of Pinhole Frequency and Density in NRX-A6 and NRX-A5 (U)

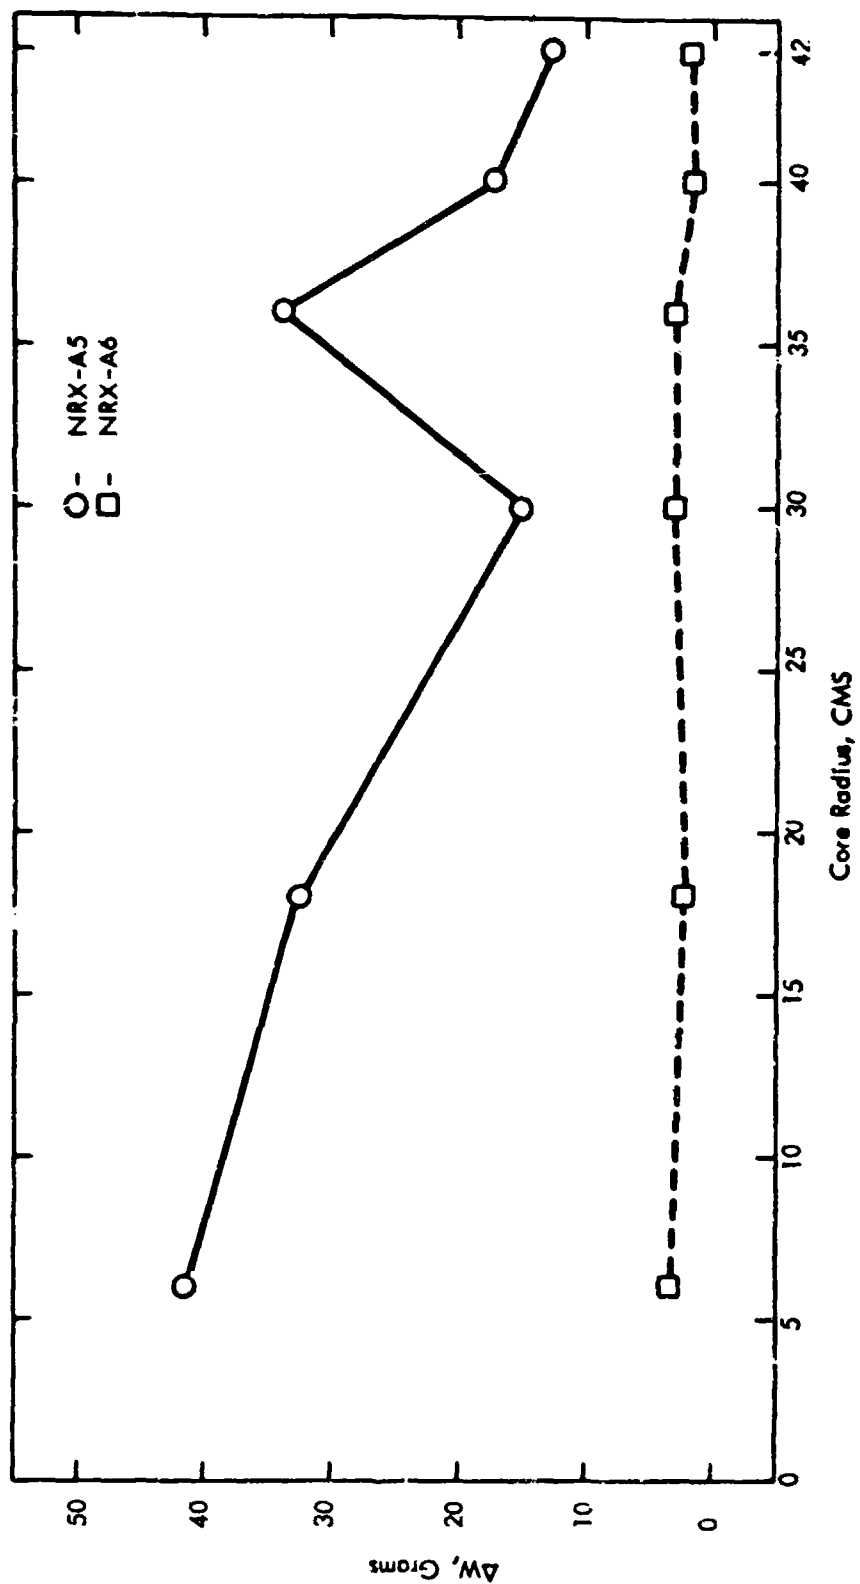
Figure 5-37. (CRD) Radial Variations of Incremental Weight Loss in the Axial Region 0-30 Inches for NRX-A5 and NRX-A6 Fuel Elements (CRD)

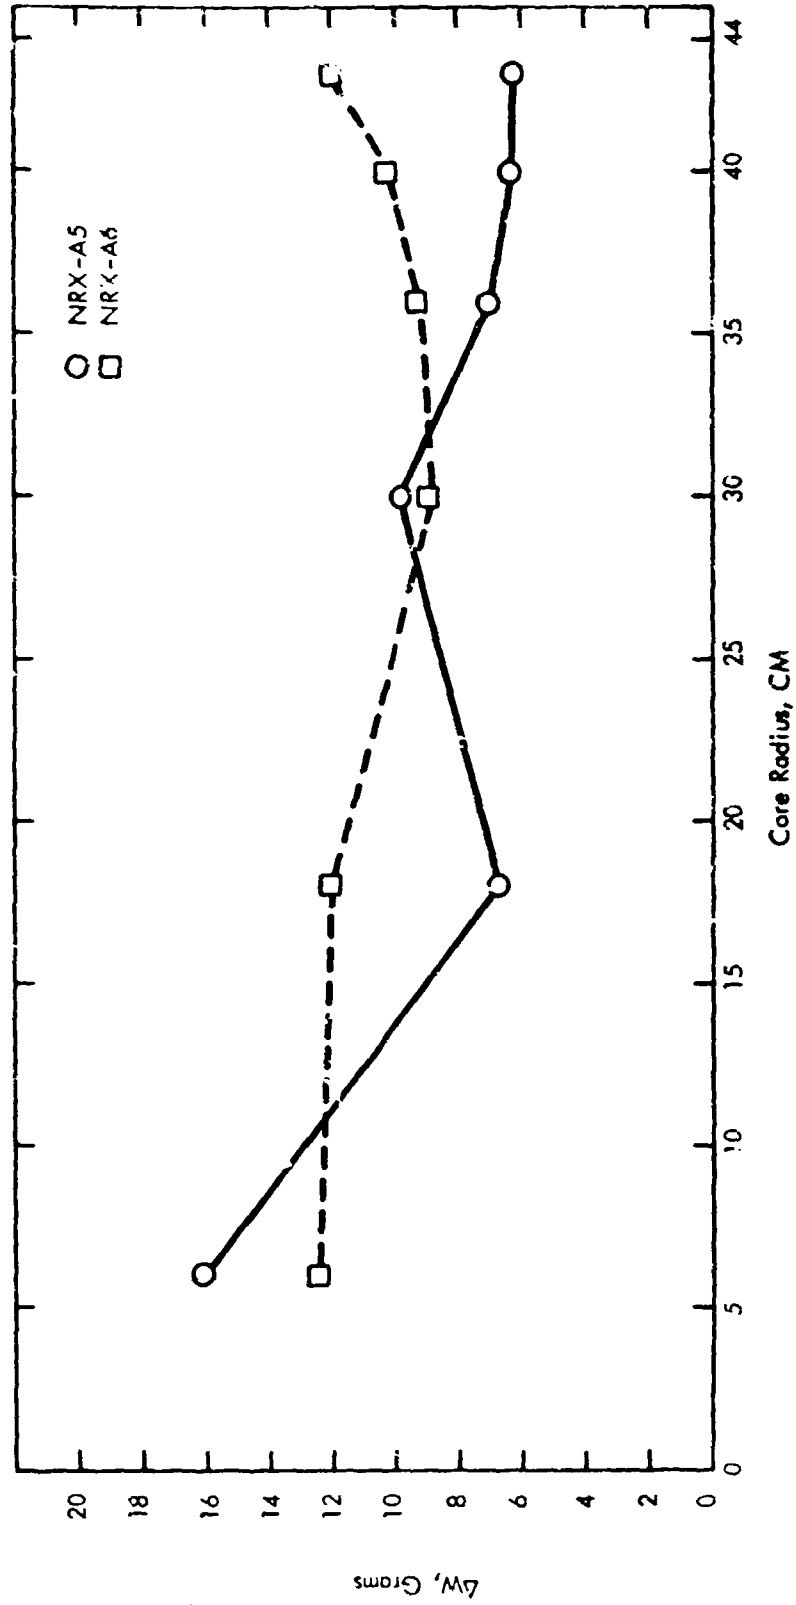
Figure 5-38. (CRD) Radial Variations of Incremental Weight Loss in the Axial Region
30 - 52 Inches for NRX-A5 and NRX-A6 Fuel Elements (CRD)
